**HERITAGE  
INTERPRETATION PLAN  
HAYMARKET LIBRARY  
744-744B GEORGE  
STREET, HAYMARKET  
NSW 2000**

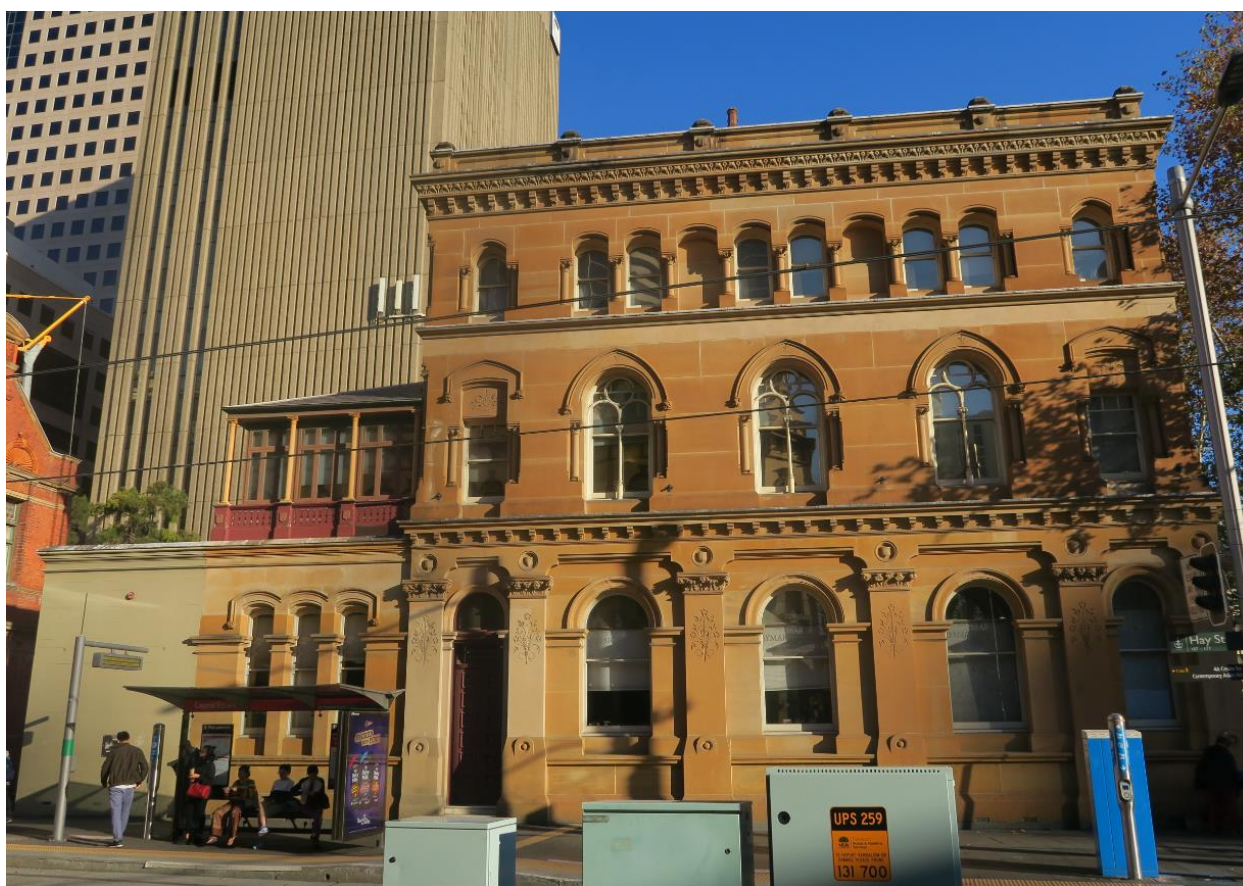
Figure 3 – Northern façade of the subject building showing original three storey principal form, original Ground Floor single storey projection with surmounting enclosed timber framed balcony. Later extension to the east discernible by painted render (left of image).

The middle three Level 1 windows on the northern façade and the three Level 1 windows on the western facade have arched window heads. The windows have a Lancet arch form, each with a small fleur-de-lis carving below the apex. The window frames on Level 2 are timber and they have an external Gothic detailing. The three arched windows on the northern façade are flanked by shorter rectangular windows. Each window opening on this level is flanked by sandstone colonettes set into the line of the façade. It appears that the window frames were replaced c1991.

The Level 1 timber structure abutting the eastern façade of the principal building form was an original feature of the building however it appears to have been originally unenclosed. It has been reconstructed after various infill elements throughout the 20<sup>th</sup> century including those which enclosed its balustrade. The timber infill windows were replaced in the 1990s. The timber infill is now set back from the decorative timber balustrade and Doric timber columns.

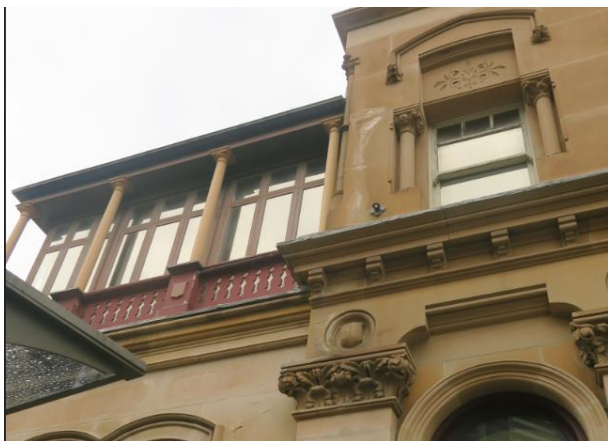
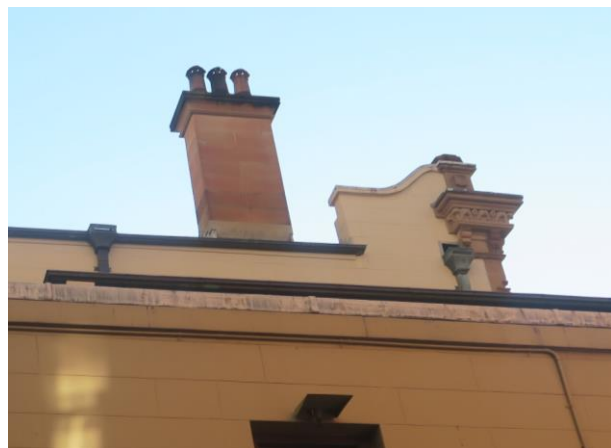
Figure 4 – View of the reconstructed original timber framed balcony with later infill setback from balustrade (left image). The eastern façade of the principal building form is only exposed at level 2. This façade is rendered brick with Ashlar course scribing. 3 copper downpipes are visible to this elevation. The northernmost downpipe is substantially tarnished (right image).

The c1925 single storey addition to the east has a metal deck roof and a cornice detail which matches the original section adjacent. The section is rendered and painted. The render has ashlar course scribing however the dimensions of the 'blocks' are smaller than the proportions of the sandstone blocks adjacent. It has no windows to the north façade but four small rectangular window openings with ventilation grilles to the eastern façade. Rainwater goods to the eastern façade are copper and are at varying stages of tarnish.

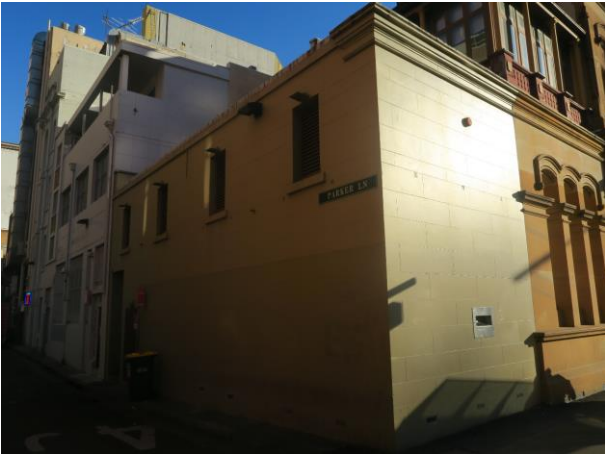
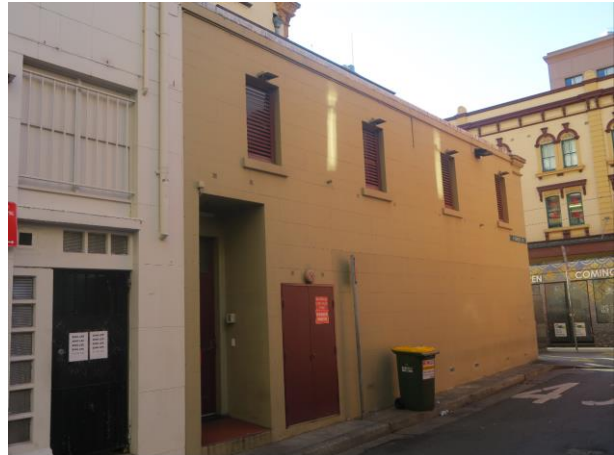
Figure 5 – View of the c1925 eastern addition showing the continuous cornice moulding from the original section returning partway along the eastern façade and ashlar render scribing (left image). View of the c1925 east addition showing the rear access to the building modified in 1991 (right image).

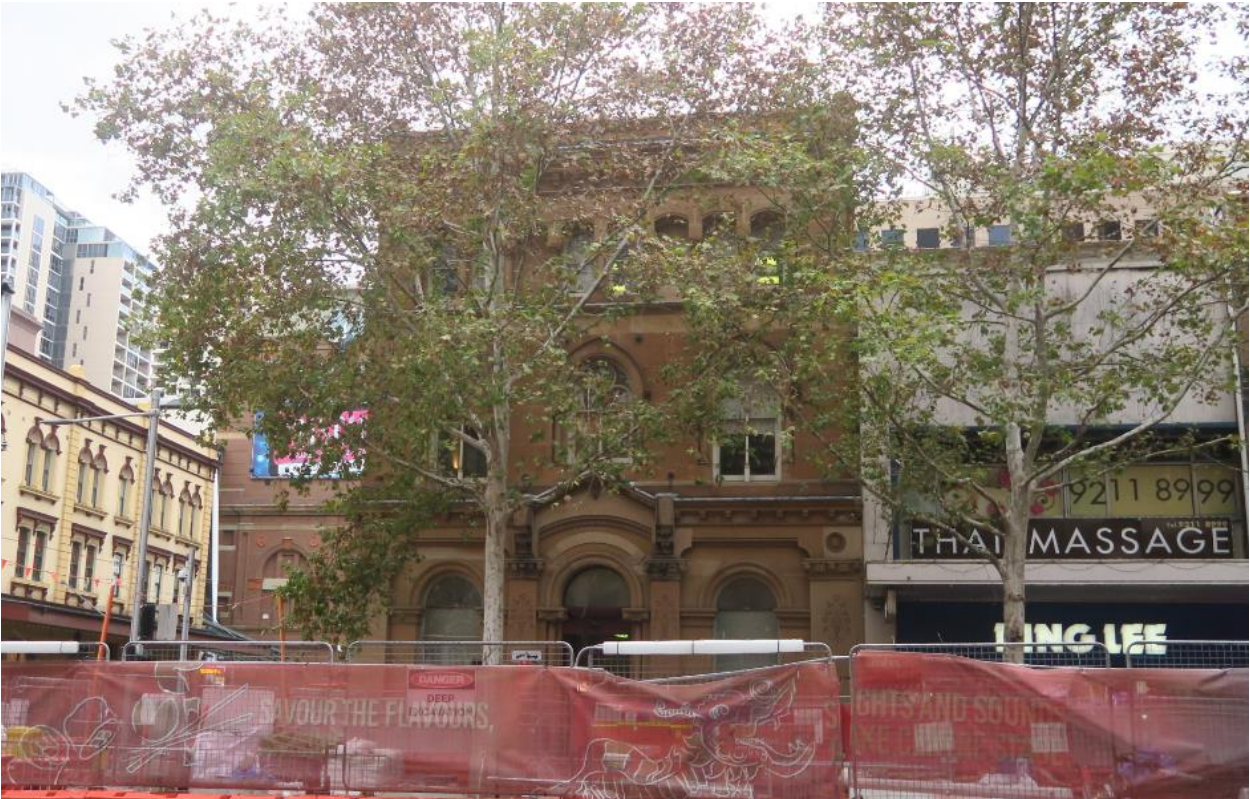
Figure 6 – Northern façade of the subject building showing original three storey form and decorative public entry.

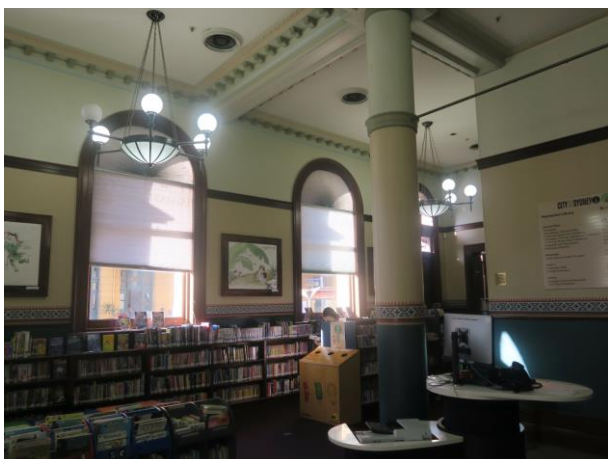
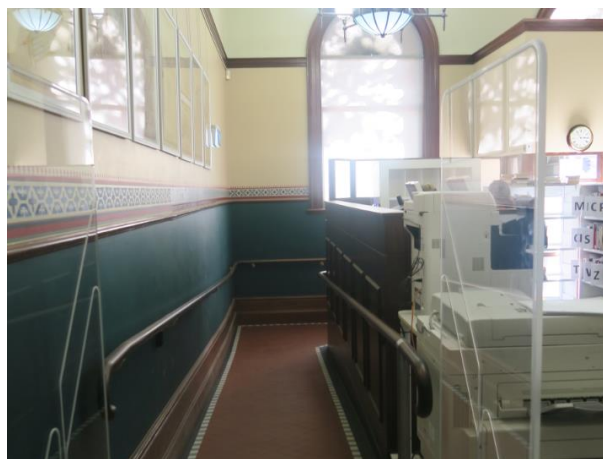
Figure 7 – View northeast across library showing a high degree of later fabric including, wall and floor finishes, dado line, vestibule area, architraves, ceiling cornices, light fittings (left image). Later accessible ramp from main entrance extending along southern wall (right image).

The Ground Floor has a number of later features constructed c1991 which are either reconstructions of the original detailing on the floor before the 1920s works or are referential to the style of the building. The Ground Floor has coffered ceilings with decorative cornices introduced in the 1990s. The 1990s restoration works to the Ground Floor specified the following: window architraves to match the existing profiles of Level 1 windows; painted stencil above the timber dado; and timber panelling to arch to east wing. The plaster ceilings cornices to this level are highly decorative, however, also the result of later works.<sup>4</sup>

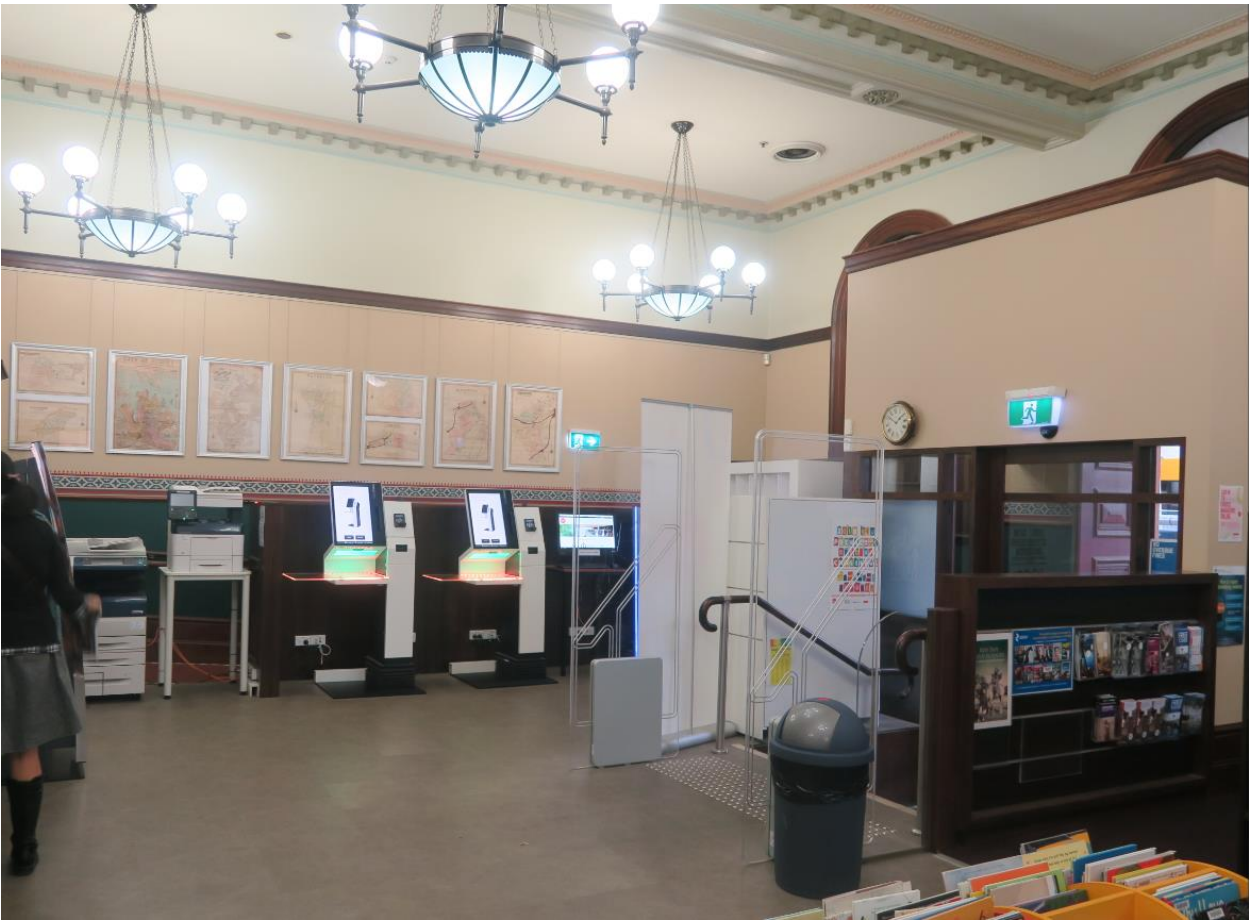
Figure 8 – View south across space to Ground Floor showing a high degree of later fabric including, wall and floor finishes, dado line, vestibule area, architraves, ceiling cornices, light fittings and furniture reconstructed with 1870s detailing.

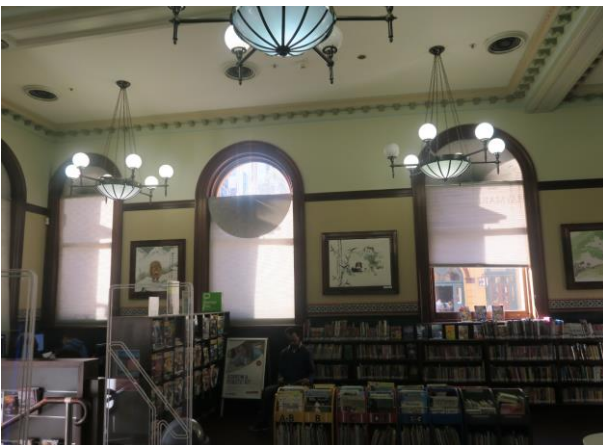
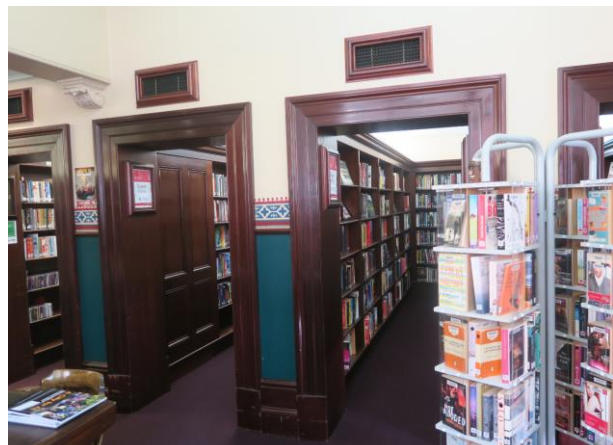
Figure 9 – View north across library showing a high degree of later fabric including Ground Floor facades and windows which were reinstated in the 1990s (left image). View south towards the stacks that extend from the eastern reading room. All joinery in this image was installed in the 1990s. The walls in this image were also installed in the 1990s however it appears that a bulkhead of the eastern wall of the original building has been retained as seen in the top left of the image (right image).

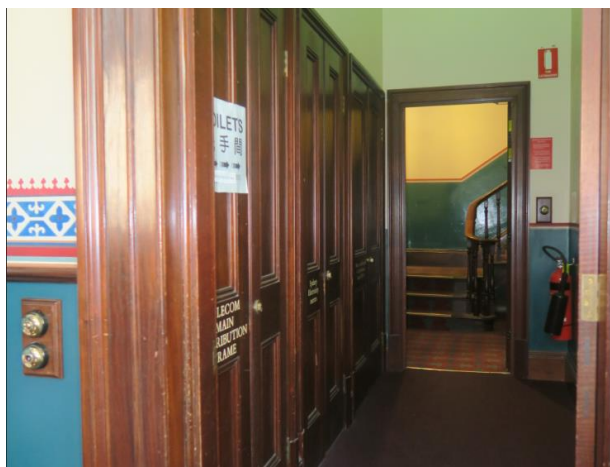
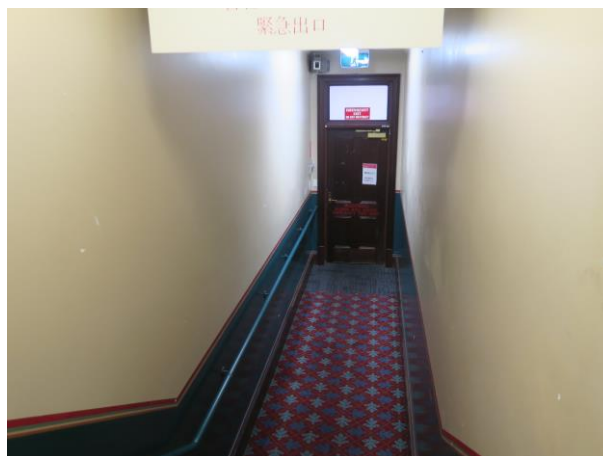
Figure 10 – View along the hall extending down the eastern side of the lift core. All joinery in this image is later except for that directly associated with the stair (including balustrade and adjacent skirting). However, the wall extending down the left side of the image towards the stair is an original wall (original east wall of principal building form) (left image). View along the rear access from the stair hall to Parker Lane. This space does not indicate the original configuration of the building. This space was previously part of the rear of the two stores facing Hay Street the former shops (right image).

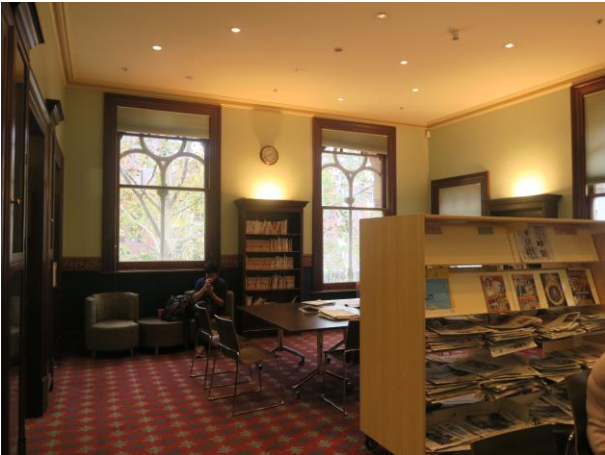
Figure 11 – View across open western room on Level 1 showing later architraves and ceilings (left image). View of new openings to bookshelf alcoves showing later architraves and cabinets display window. The wall to the left of the image appears to be an original wall with later openings (right image).

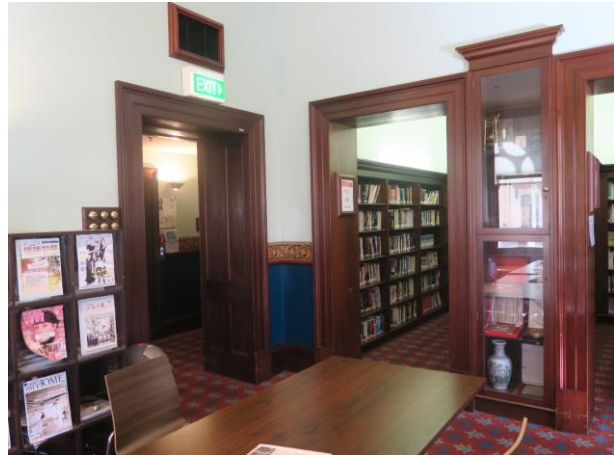
Figure 12 – View over the joinery associated with the book stacks showing an original chimney breast to the southern wall of Level 1. Further investigation may reveal original fireplaces behind later joinery (left image). View east towards later opening in original wall between front room and adjoining reading room on Level 1 with referential joinery. Later air conditioning register is visible above opening (right image).

The eastern extent of this level is occupied by the timber framed space which is an original balcony that was previously enclosed and subject to extensive reconstruction works in the 1990s. The space is currently used for study. The space has operable timber casement windows which are set back from the original balustrades. It has timber ceilings with air conditionings registers and contemporary downlights.

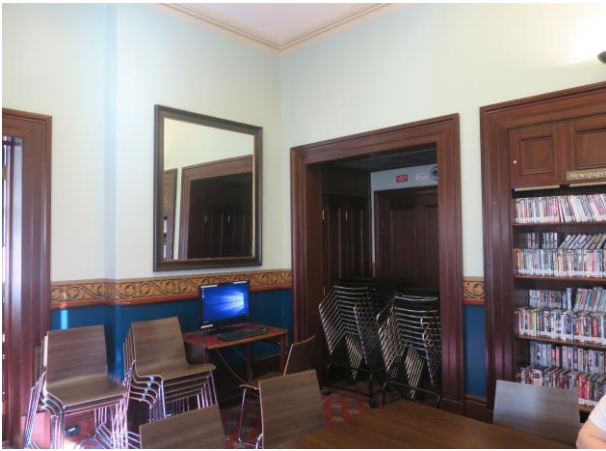
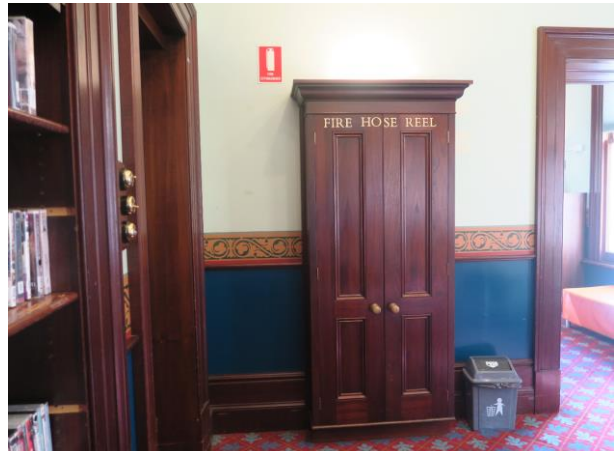
Figure 13 – View east across Level 1 reading room showing later referential timber joinery (architraves, cupboards and bookshelves) to the right of the image. The wall on which this joinery is located is a later wall. The wall to the left of the image is an original wall (southern wall of the principal building form) and the remnant of a chimney breast is legible (left image). View west across Level 1 reading room showing later referential timber joinery (fire hose reel, architraves and bookshelf) the wall directly in front appears to be an original wall with later openings (right image).

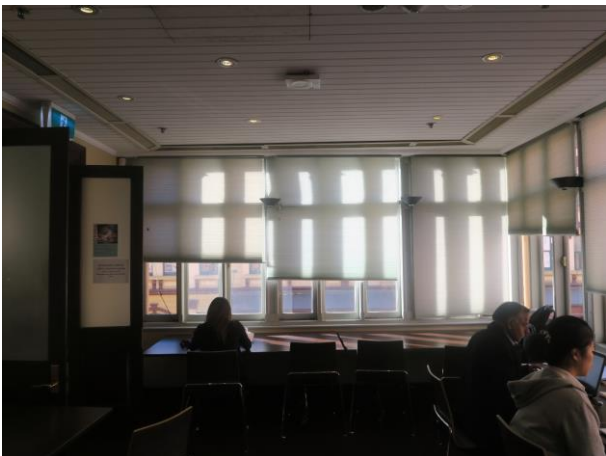
Figure 14 – View across the rear timber framed space showing timber ceilings with multiple penetrations. The double doors to access this space are timber with glass infill panels (left image). View along the rear hallway from the stair hall at level 1. This space does not indicate the original configuration of the building. Two bathrooms are now accessed from this hallway which were installed as part of the 1990s restoration works (right image).

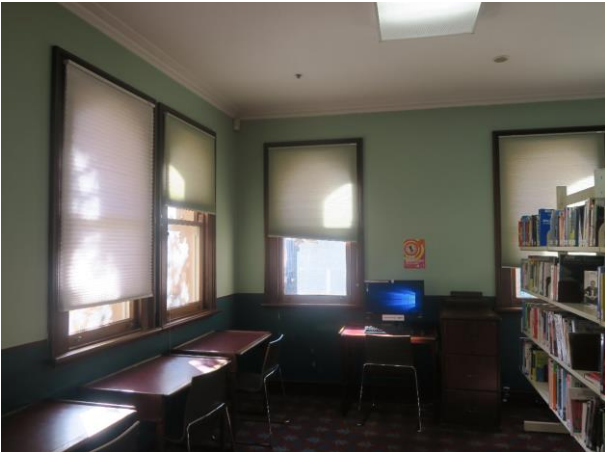
Figure 15 – View across open eastern room on Level 2 (left image). View of ceiling to Level 2 space showing suspended ceilings, cornices, contemporary light fittings and air conditioning duct. An original chimney breast is also visible on the southern wall (right image).

Level 2 has a public reading room to the west. The space to the north of the lift is occupied by an office for library staff. The ceilings in this space are contemporary suspended types. The ceilings have plaster cornices and a number of penetrations for services including light fittings and air conditioning ducts. An original chimney breast is extent on the southern wall of the western space. However, there is no fireplace.

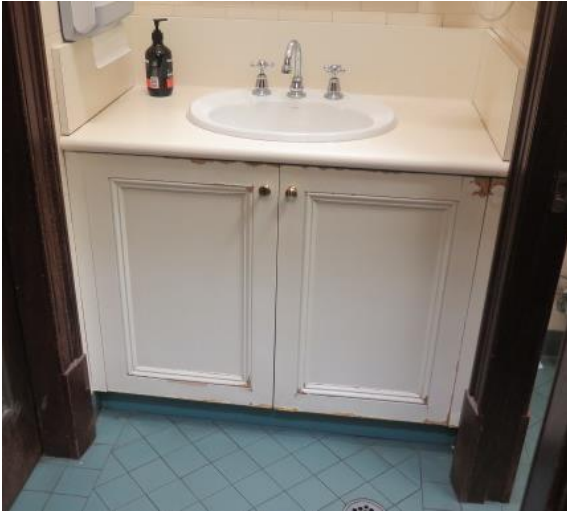
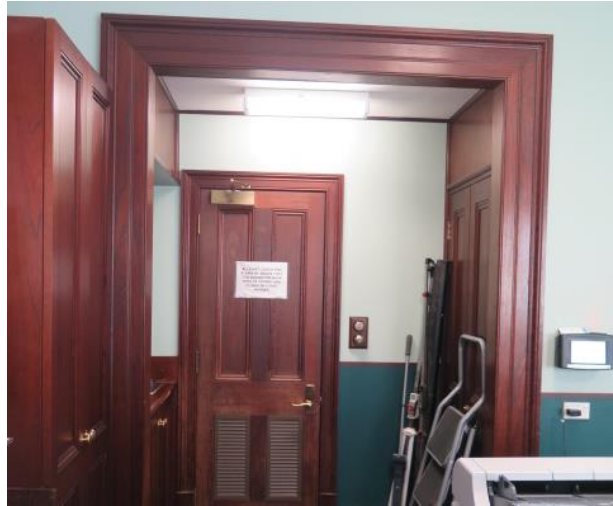
Figure 17 – Later bathroom fit-out to space off office at Level 2 (left image). Later joinery to bathroom off office space (right image).

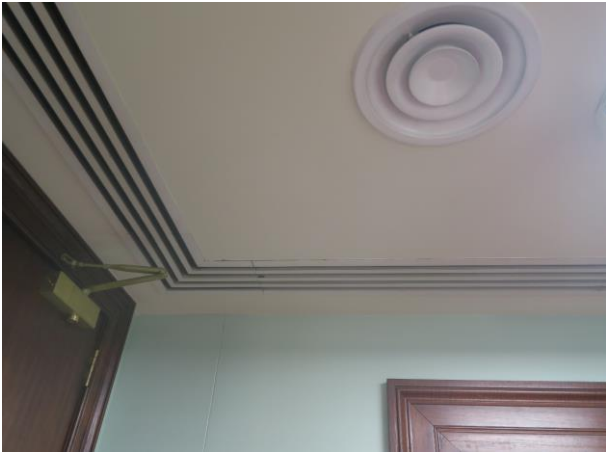
Figure 18 – Ceiling to hall adjacent to lift at Level 2 (left image). Arch to western wall of stairwell at Level 2 (right image).

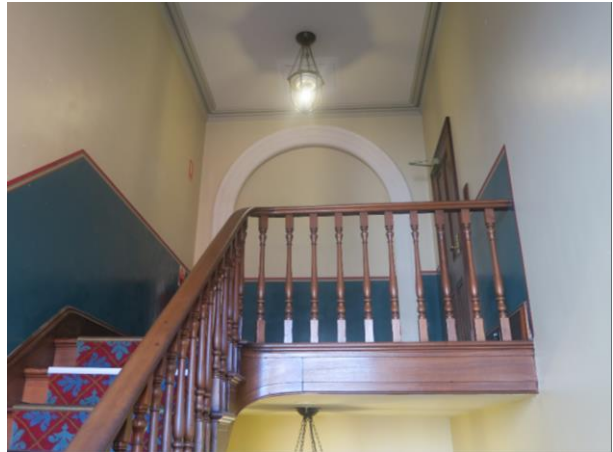
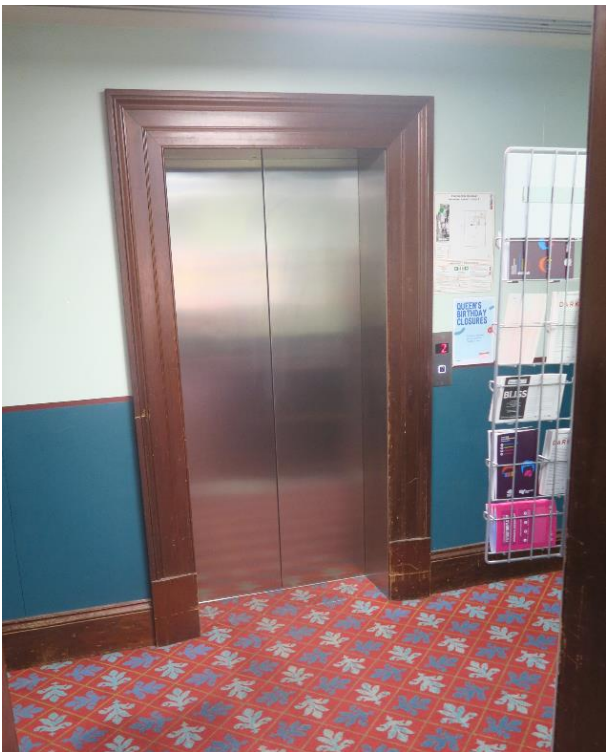
Figure 19 – Lift doors from Level 2 showing all later joinery (left image). Flight of stairs between Levels 1 and 2. The stairs appear to be original in terms of both fabric and configuration. However, some balusters appear to have been replaced (right image).

The stairwell is located adjacent to, and south of, the lift well and services all floors. The stairwell is original, and the space appears to comprise the highest degree of original fabric in the building. The stairs (including the balustrade) appear to be original in terms of both fabric and configuration. However, some balusters appear to have been replaced. The timber skirtings in the stairwell also appear to be original.

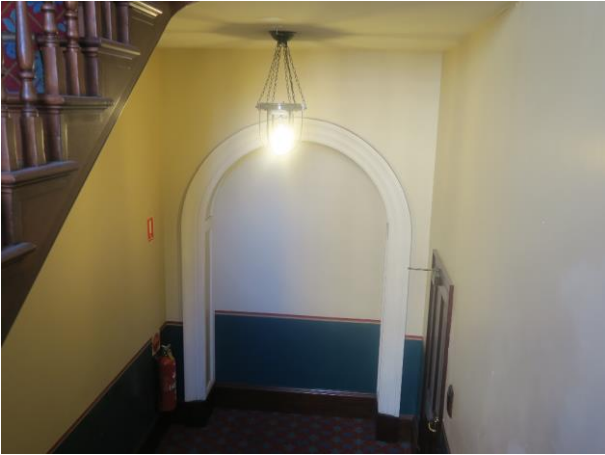
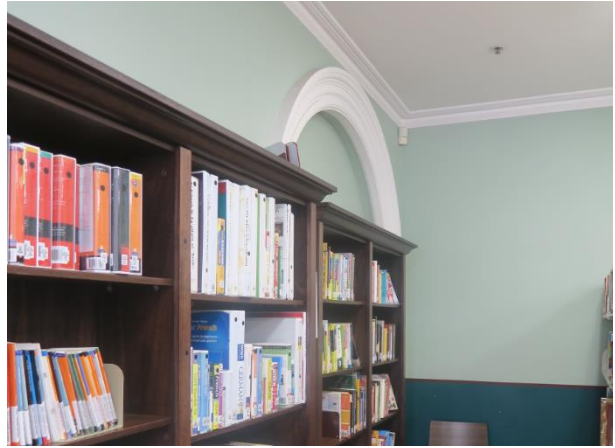
Figure 20 – Arch to western wall of stairwell at Level 1 (left image). View of original infilled arch from reading room at Level 2 (right image).

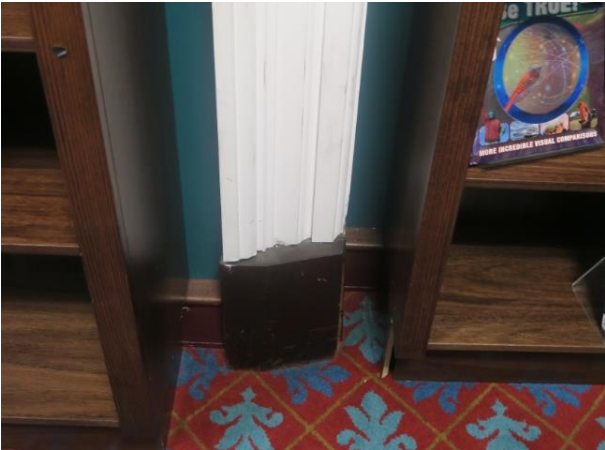
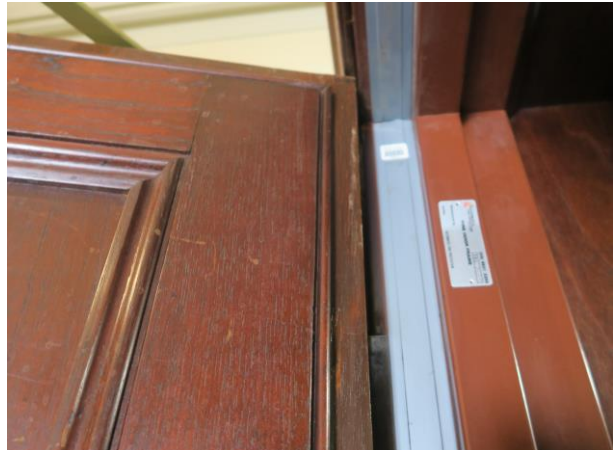
Figure 21 – View of base of original infilled arch from reading room at Level 2 (left image). Fire door constructed in 19<sup>th</sup> century referential style with timber outer and steel core (right image).

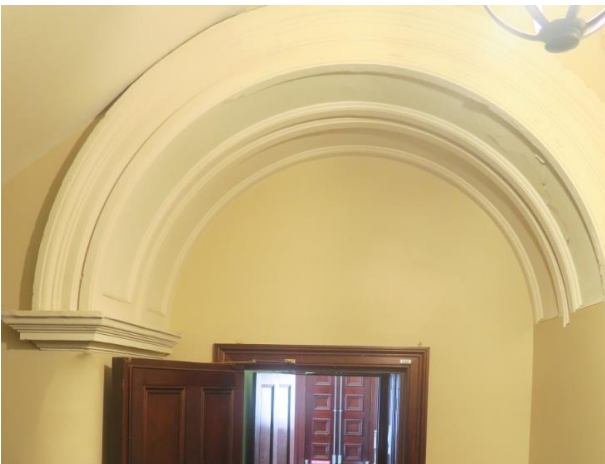
Figure 22 – Arch to stairwell at Ground Floor (left image).

There is an arch at Ground Floor near the termination of the main stairs. The arch extends from the rear (eastern) face of the original strong room across the hall and frames the axis which extends from the bottom of the stairs to the Hay Street entry. The arch appears to be original.

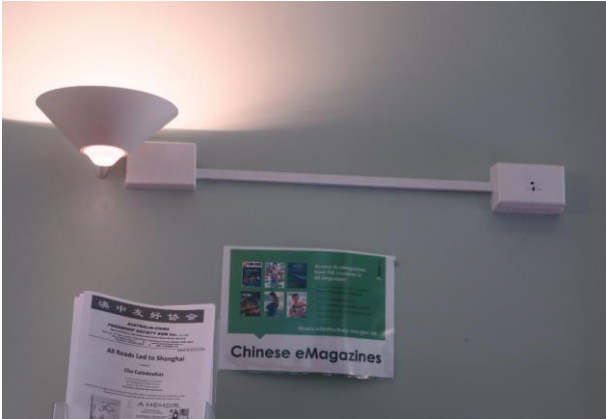
Figure 23 – Surface mounted services to Level 1 (left image) Surface mounted services to stair well (right image).

Services throughout the building date to 1990s. Services have generally been installed in a sympathetic way i.e. surface mounted rather than chased into original walls. Services are run along the floor through later ducted skirtings. Later air conditioning registers on walls are visible throughout. The air conditioning registers have referential timber surrounds and metal grilles over the openings. Light switches throughout are contemporary however have the detailing of earlier switches. Light fittings throughout are later.

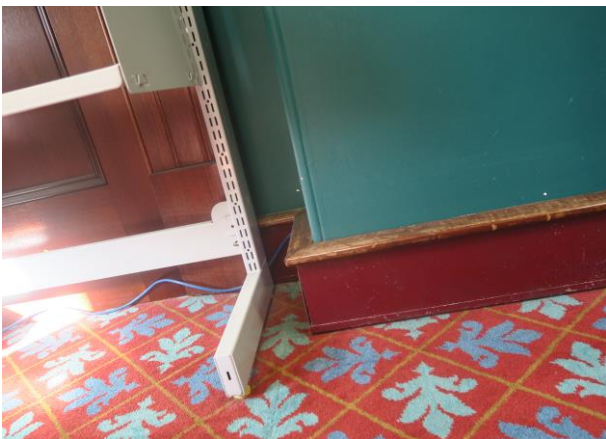
Figure 24 – Ducted skirtings (left image) Air conditioning register in wall on Level 1 (right image).

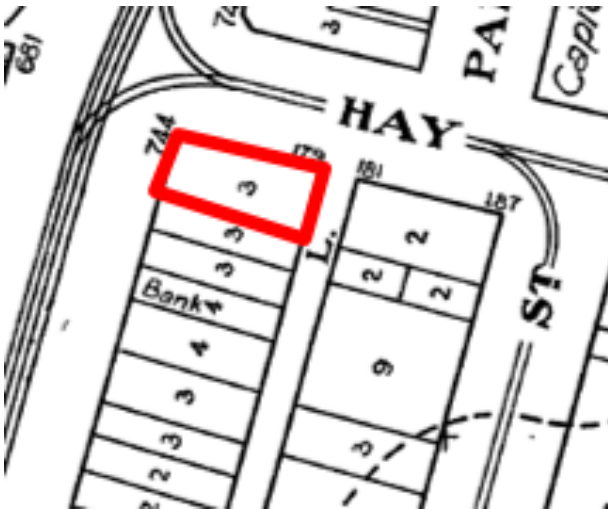
Figure 58 – Detail from two surveys of the City of Sydney showing subject site. On left: City of Sydney Civic Survey Ultimo and Haymarket, 1938-50. On right: City Building Surveyor's Department Detail Sheets, Sheet 10, 1949-72.

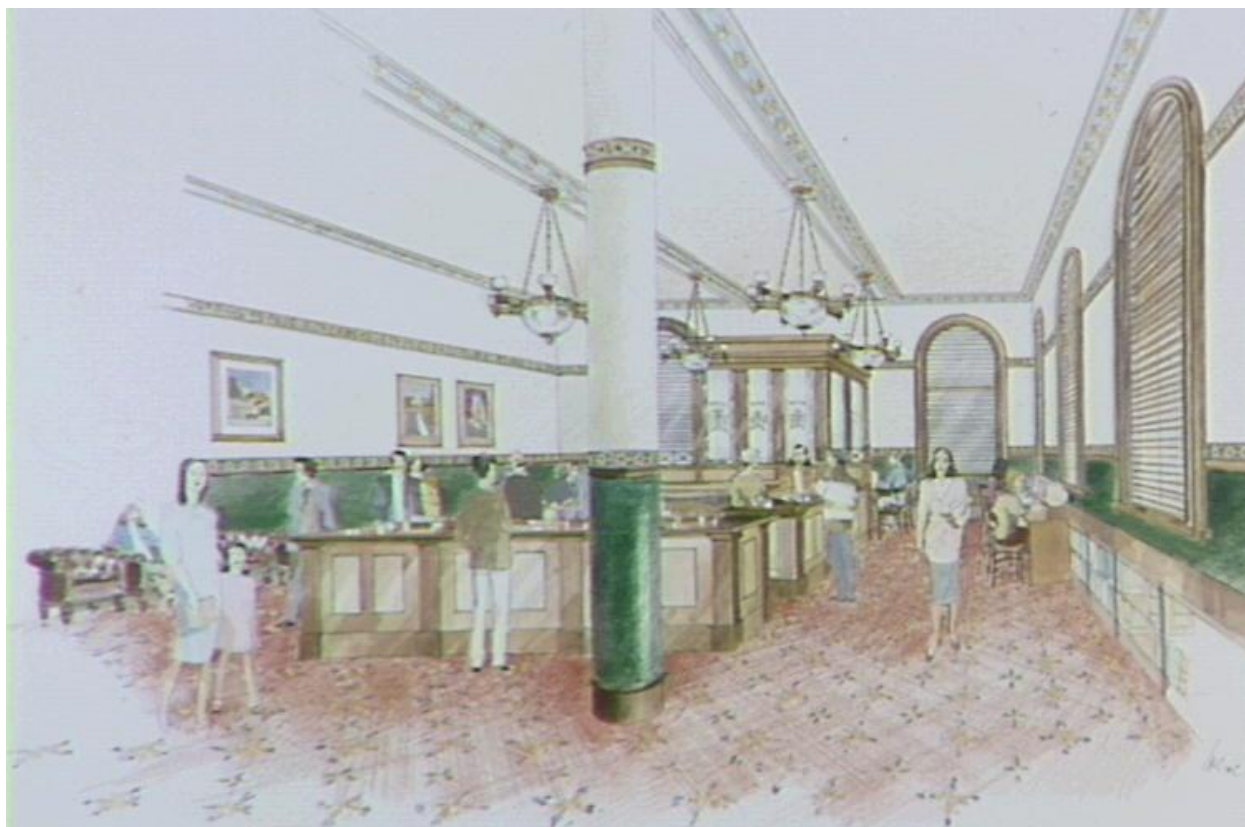
Figure 64 – Restoration of Haymarket Chambers – interior sketch of the proposed Haymarket Library, 1991-92.

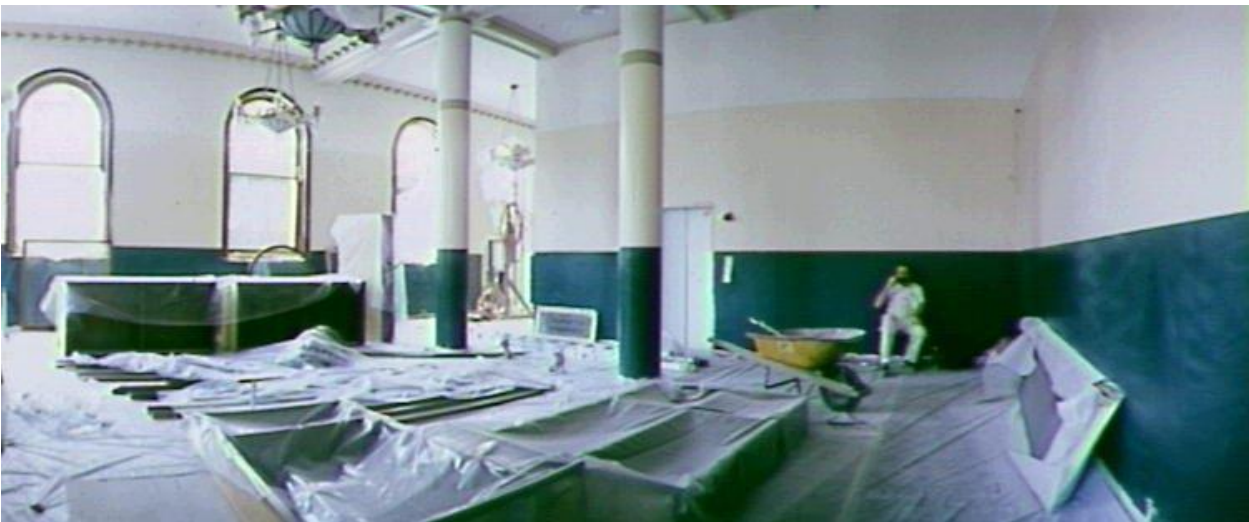
Figure 66 – Restoration of Haymarket Chambers – view of the Ground Floor looking towards the proposed location of the circulation desk, 1991-92.

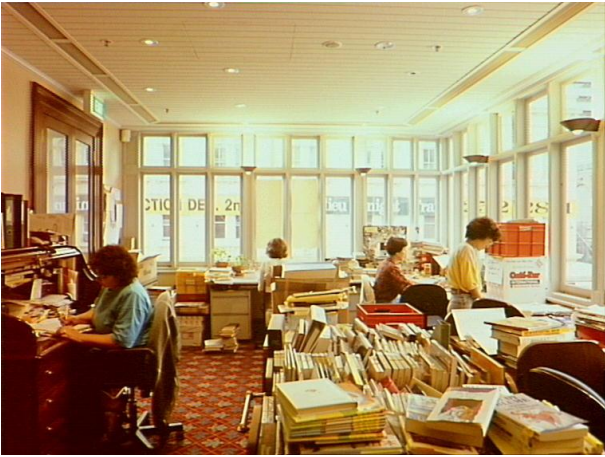
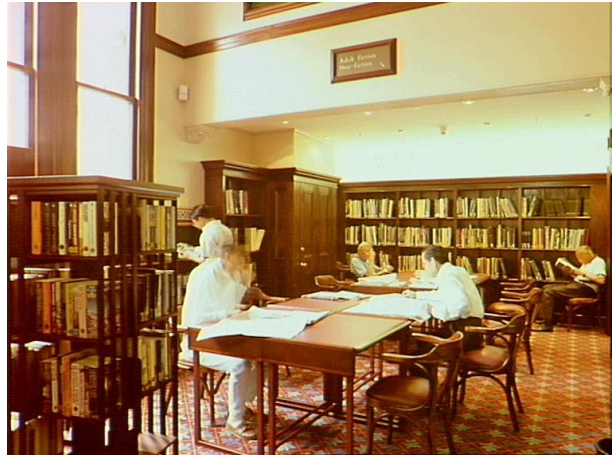
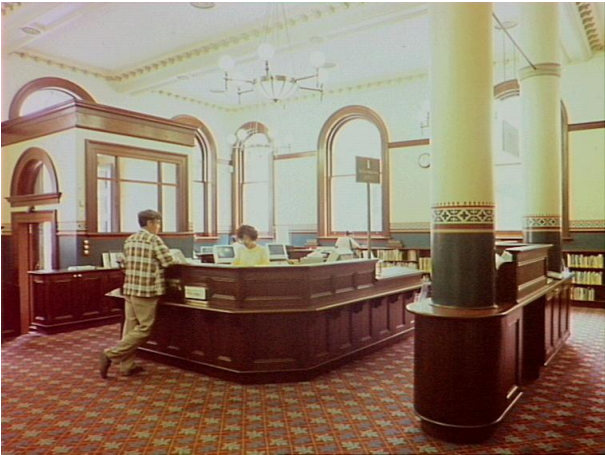
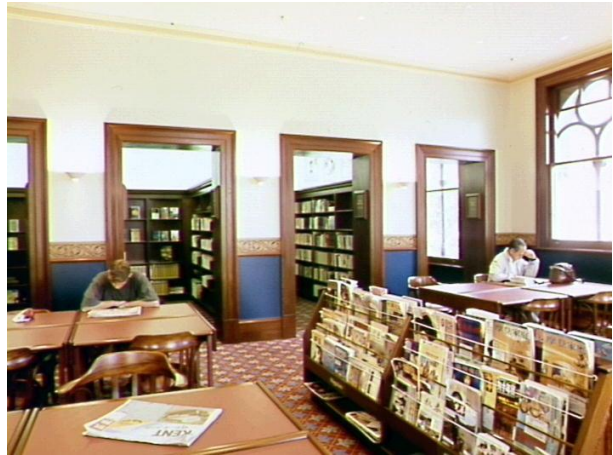
Figure 70 – Restoration of Haymarket Chambers – interior views showing new Haymarket Library, 1991-92.

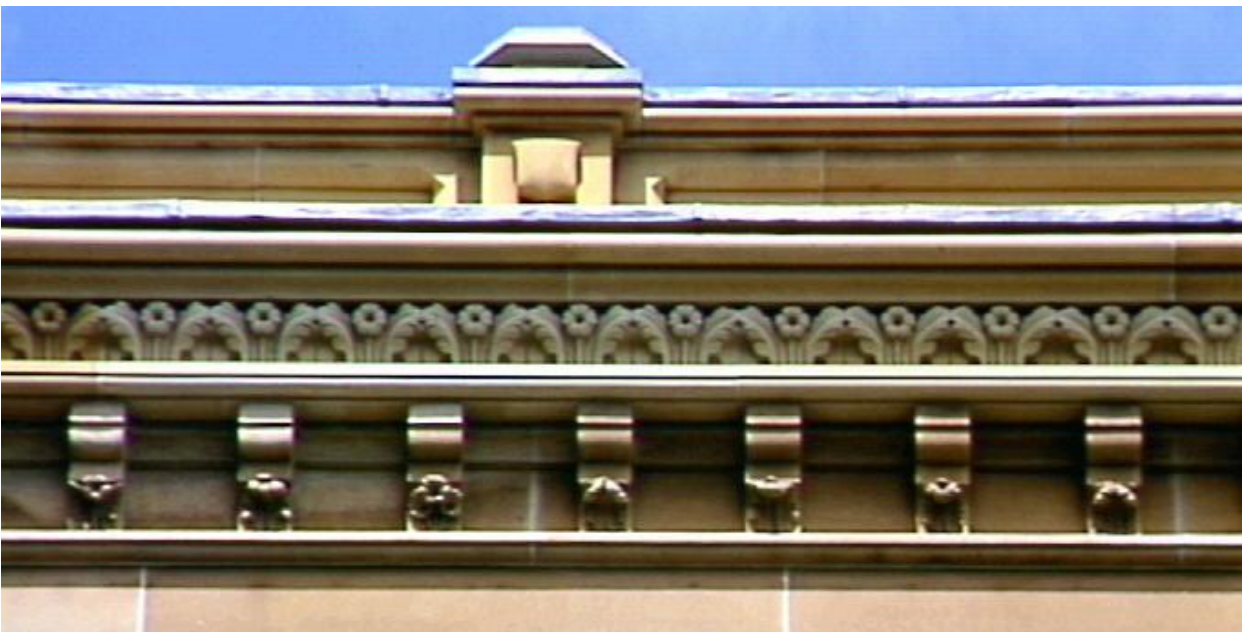
Figure 71 - Sandstone elements on facade, 1991-92.

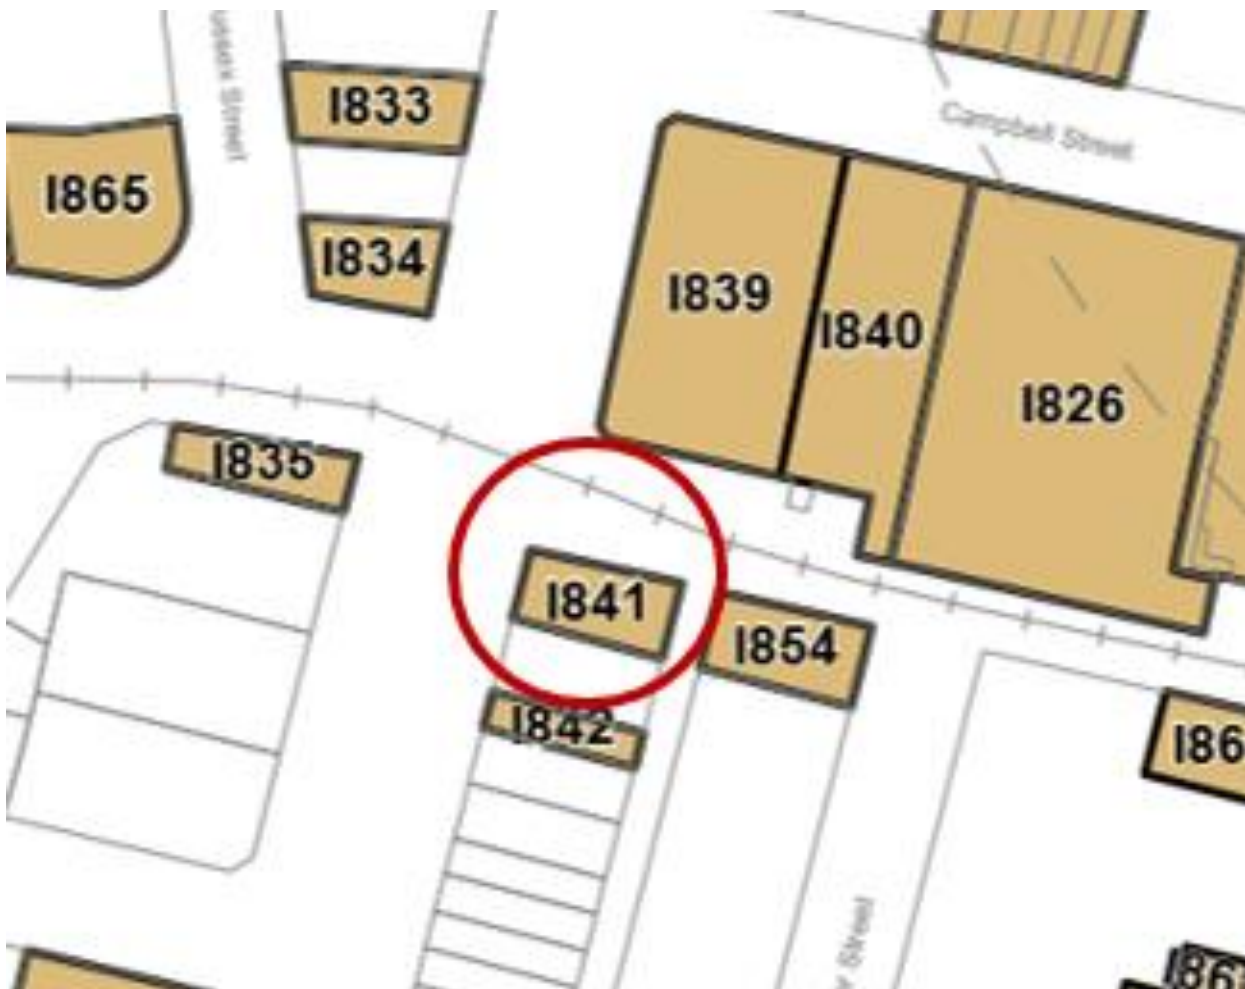
Figure 80 – Heritage Map showing subject site (I841).

The subject site is identified as an item of Local significance as 'Former "Haymarket Chambers" including interior' (item I841\*) under Schedule 5 of the *Sydney Local Environmental Plan 2012*. The subject site is not located within a heritage conservation area". See Figure 1 and Figure 80 for the location of the heritage item and the relevant conservation areas.

The subject site is listed as a heritage item the “Former “Haymarket Chambers” (Item 841) under, Schedule 5 Environmental heritage, of the *Sydney Local Environmental Plan 2012*, and is shown on the heritage map (see Figure 80). The Heritage Map, also shows the location of other heritage items in the vicinity of the subject site.

This Heritage Interpretation Plan has been prepared for the City of Sydney in conjunction with the Conservation Management Plan (2018), prepared by Urbis. The subject site, located at 744-744B George Street, Haymarket is known today as the Haymarket Library. Haymarket Library is one of the nine library branches operated under the City of Sydney. The subject site, is listed as a heritage item under, Schedule 5 Environmental heritage, of the *Sydney Local Environmental Plan 2012*, and is shown on the heritage map (see Figure 80). It is referred to as “Former Haymarket Chambers” (1841).

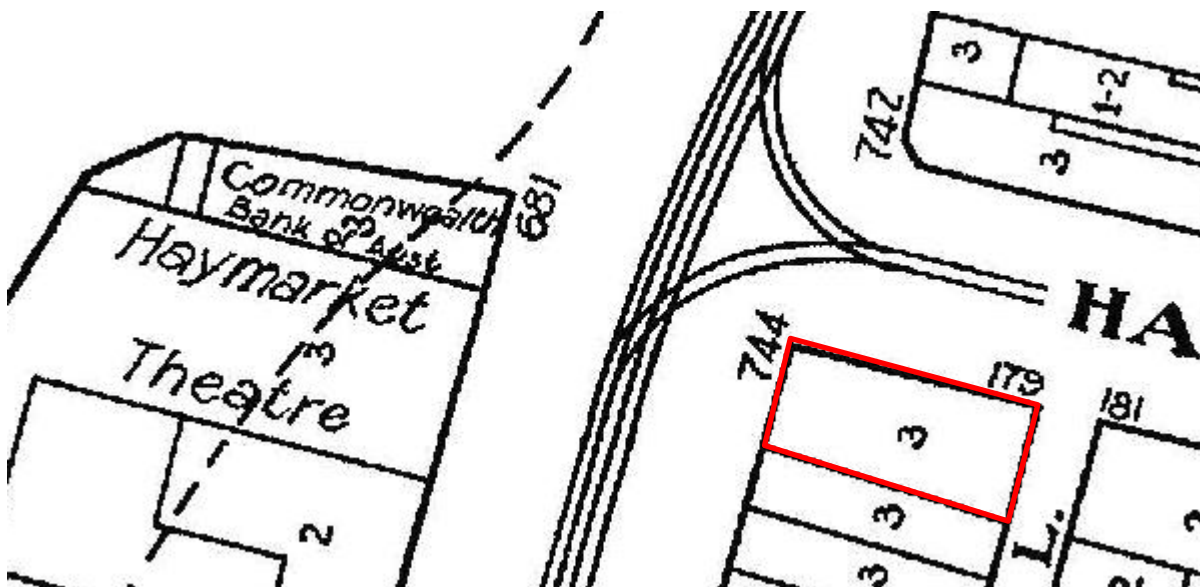
Figure 81 – Civic Survey Map, 1938-1950 with subject site indicated in blue directly across from the Haymarket Theatre.

Directly west of the subject site was the Haymarket Theatre. The Haymarket Theatre is notably present on the 1938-1950 Civic Survey map (Figure 81). The Haymarket Theatre was constructed c 1916, known first as the Haymarket Theatre, before becoming a picture theatre, known as The Civic Theatre in the 1930s. It is referenced as the Palladium Theatre in the 1949-1972 Building Surveyor's Detail Sheet and was present until c 1960.

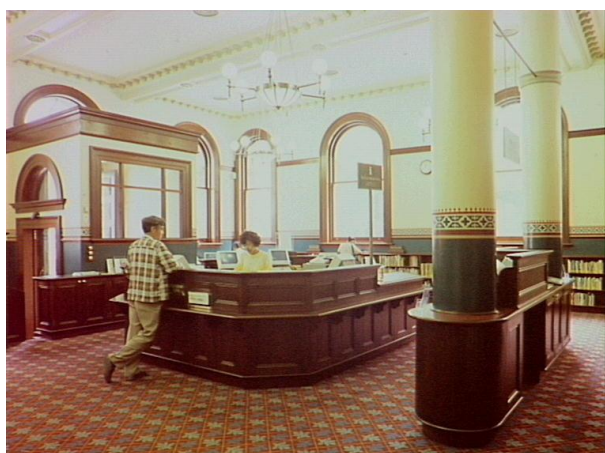
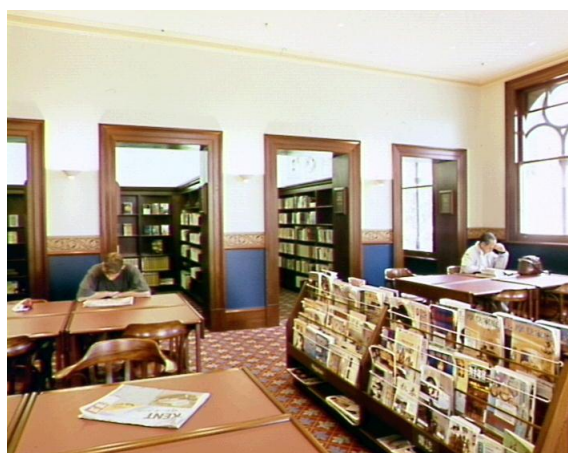
Figure 88 – Photographs of the newly restored Library Branch in the early 1990s. Left, Ground floor Library services desk. Right, First floor reading areas showing the alcoves housing the Asian language books.

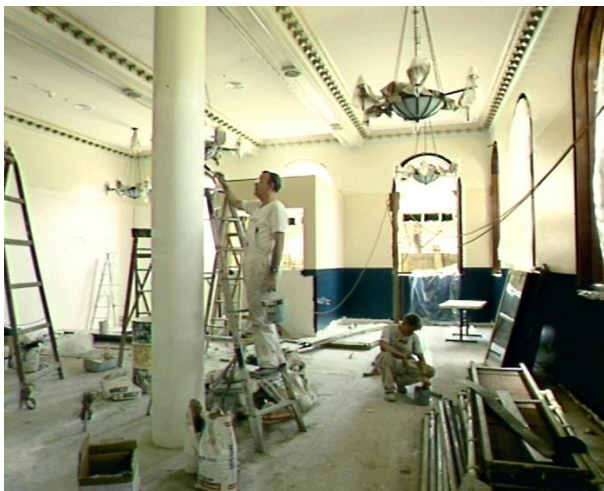
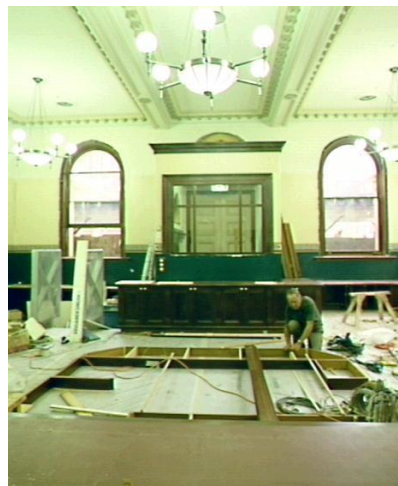
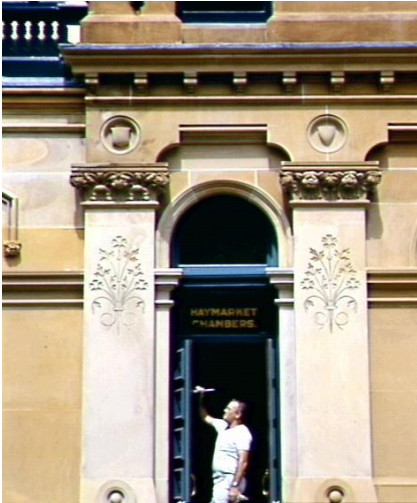
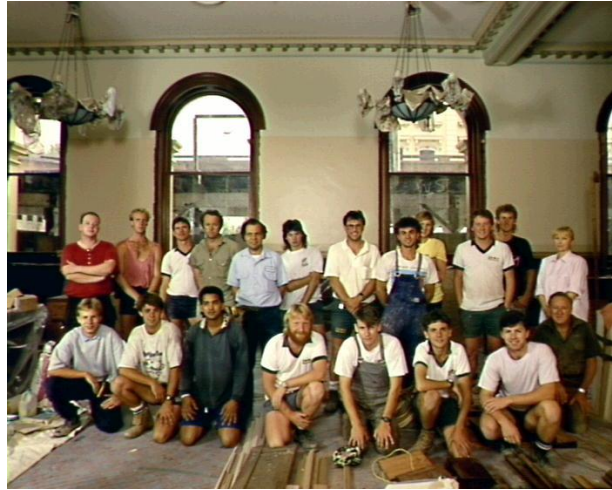
Figure 92 – Photographs of the Restoration of 744 George Street Haymarket, 1991-92. Top left, interior during renovation. Top right, preparing the space for the desk on the ground floor. Bottom left, exterior restoration. Bottom right, restoration team.
