**HERITAGE  
INTERPRETATION PLAN  
HAYMARKET LIBRARY  
744-744B GEORGE  
STREET, HAYMARKET  
NSW 2000**

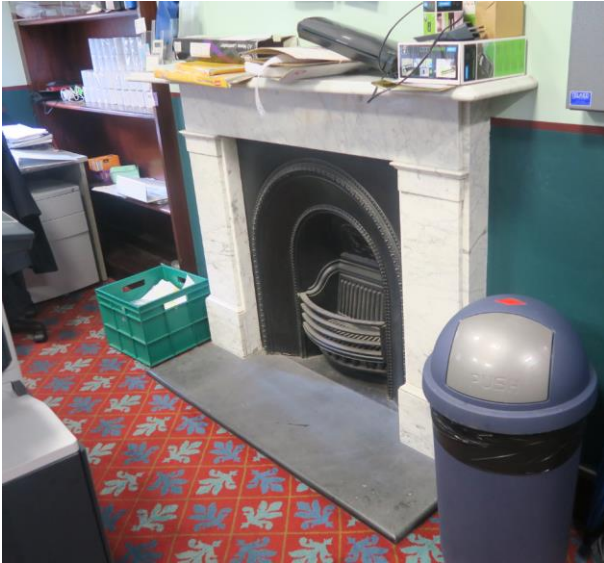
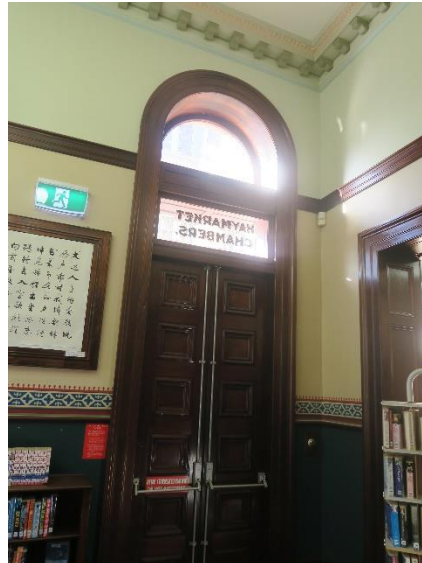
Figure 93 – Built form fabric of high significance. Top left, fire place located on level 2. Top right, Hay Street entrance with original fanlight. Bottom left, main staircase. Bottom right, northern (Hay Street) façade.

The following areas have been graded as having 'High Significance' and should be retained as part of a built form interpretation strategy. It should be noted that the areas outlined below are only a sample of the significant areas outlined in the CMP.

- The original strong room has remnants in the original location. This should be retained and could be further interpreted through the use of in-floor markers or signage. It should be noted that it is unknown how much of the original fabric remains as throughout the building's history, this area was altered. However, the location of the strong room is the part of the original and structure. There is opportunity to interpret the original use of the building as a bank.

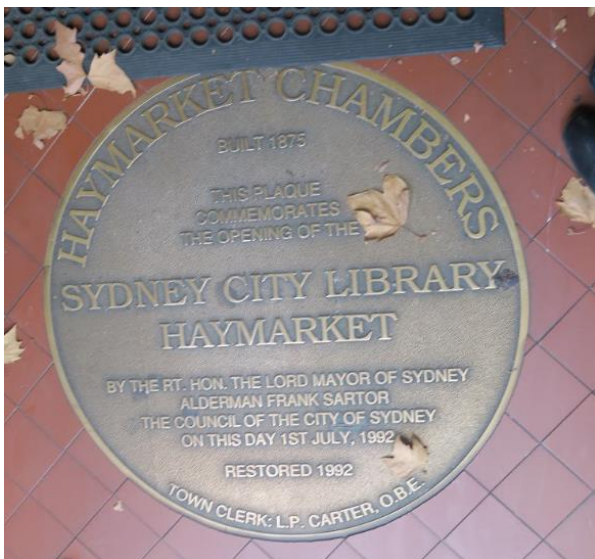
Figure 97 – Historic marker present on the floor of the subject site on the Ground Floor at the George Street entrance.

The architectural history of the subject site should be explored through exterior signage. It should be noted that a brass historic marker is already present within the building on the Ground Floor at the George Street entrance. Another might be considered for the exterior at the Hay Street entrance to further interpret the Chambers phase of the building in conjunction with the fan light above the entrance way.
